El Conquistador Resort Patio Homes *Oro Valley, AZ*

Report #: 20889-5
Beginning: January 1, 2024
Expires: December 31, 2024

RESERVE STUDY Update "With-Site-Visit"

May 24, 2023

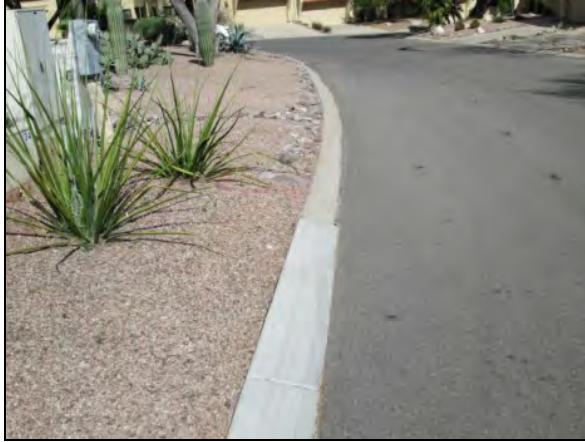
Comp #: 103 Concrete - Repair

Comments: There is no expectancy to completely replace the concrete. This component provides an allowance for periodic repairs and/or partial replacements. Minimal amount of cracks noted.

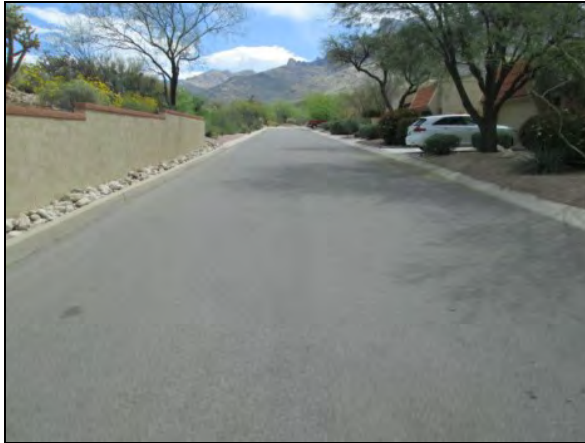
Comments: Asphalt is smooth and in good condition. This component funds to remove and repave the asphalt. Life span is based on periodically seal coating and maintaining the surface. Since the price of asphalt has dramatically increased since the streets were repaved, we are not using the 2022 cost for future pricing.

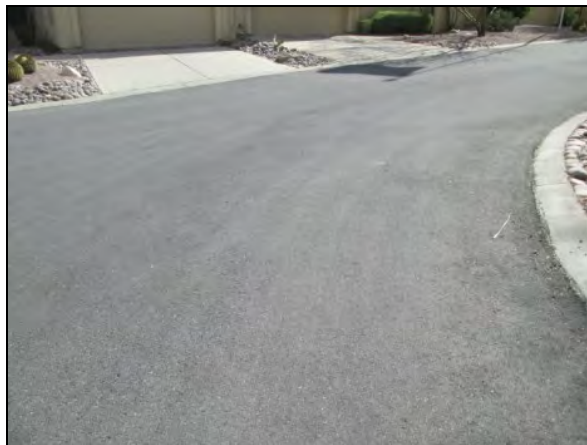
Comp #: 203 Asphalt - Seal/Repair

Comments: Asphalt was not sealed at the time of inspection. Seal coat asphalt surfaces periodically to prevent premature cracking and deterioration.

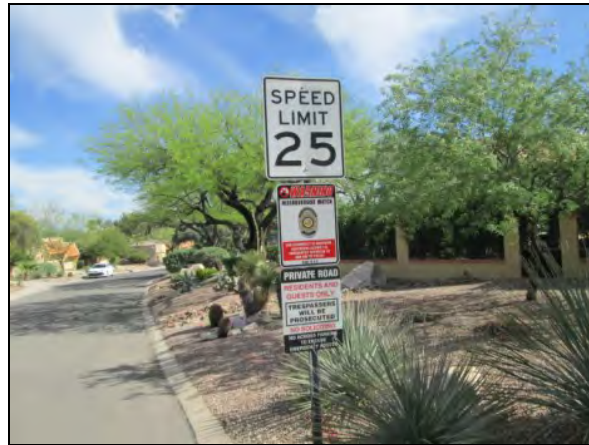
Comp #: 300 Street Signs - Replace

History: Reportedly replaced around 2022 (cost unknown). Previously replaced in 2008.

Funded?: No. HOA plans to replace as needed with Operating funds, so no Reserve funding has been allocated.

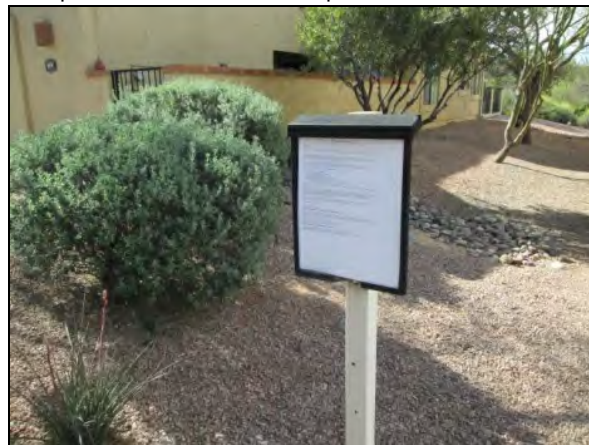
Comp #: 302 Notice Boxes - Replace

Comments: These boxes are used to display the community notices. They still appear intact and in fair condition. Some weathering and wear noted. Future replacement should be anticipated.

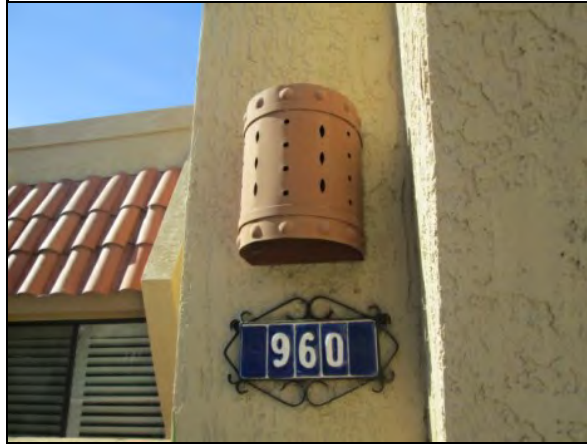
Comp #: 324 Wall Lights - Replace

History: Replaced in 2014 for ~\$28,000. Installed in 1985.

Comments: The association is reportedly responsible to replace these lights. Quantity reflects extra lights purchased for one-off replacements. They are still attractive and functional. Complete replacement should be anticipated.

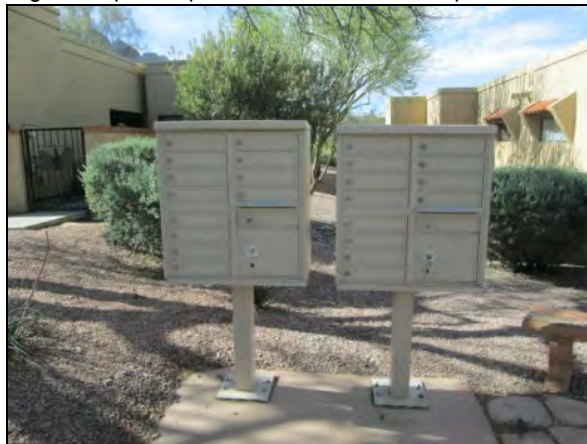
Comp #: 403 Mailboxes - Replace

Comments: Quantity includes (3) 2-box clusters, (4) 8-box clusters, (6) 12-box clusters, and (7) 16-box clusters. Mailboxes are in fair condition with no notable damage. Complete replacement should be anticipated.

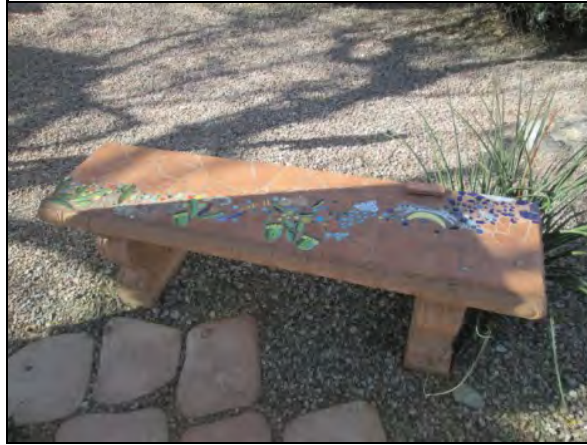
Comp #: 405 Benches - Replace

Comments: These tiled concrete benches. They are generally intact and in fair condition, but many of them are beginning to crack. Long life component, however, replacement should still be anticipated.

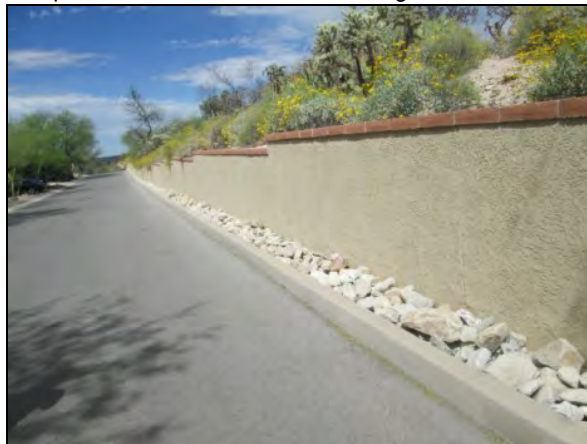
Comp #: 501 Stucco Walls - Repair

Comments: Walls are expected to last the life of the community under normal circumstances. This component provides an allowance for repairs and/or partial replacement due to excessive settling or other sources of damage.

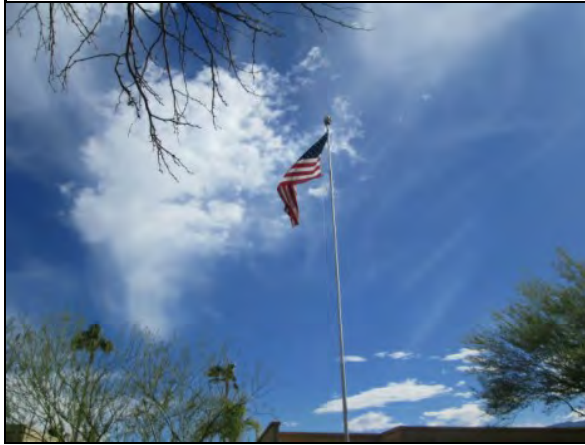
Comments: There is no expectancy to actually replace the flag pole. This component provides funding to refurbish the flag pole again at some point in the future.

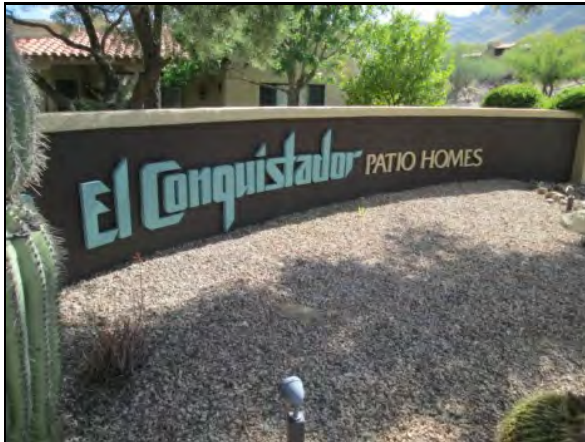
Comments: The monument consists of metal reverse pan channel letters mounted to a stucco wall. The monument reads "El Conquistador PATIO HOMES." This component provides funding to replace the logo and letters. The monument was recently repainted, so there is no expectation to refurbish it in the near future.

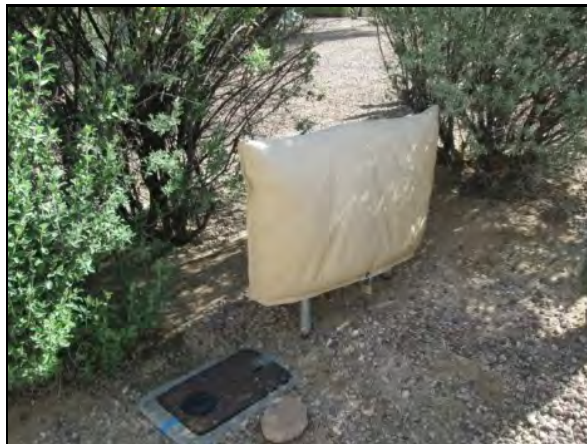
Comp #: 1001 Backflow Valves - Replace

Comments: Backflow valves typically last a long time. However, it would be prudent to still plan for replacement eventually. No problems observed or reported.
